Joint Load Transfer and Slab Loss of Support Analysis

**Research
Development
and Technology
Division**

Missouri
Department
of Transportation

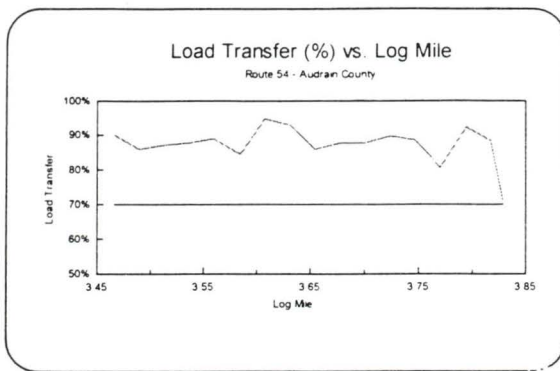
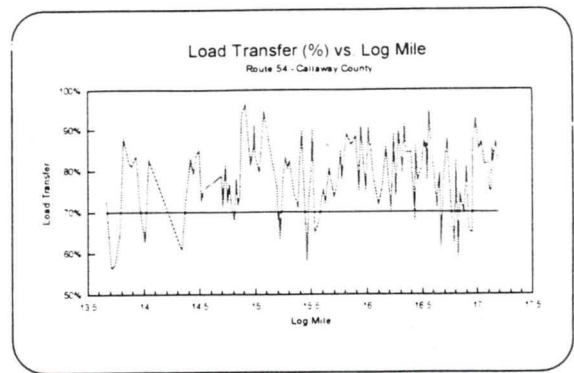
The center deflection and deflection basin area plots show that the pavements are in good structural condition. According to the Void Size Estimation Procedure, none of the pavements exhibited any sign of voids beneath the pavement. The major difference was reflected in the joint load transfer values. The Route 54, Callaway County pavement's load transfer values were irregular, with nearly 20% of the joints being below the limit for good load transfer (70% load transfer). The other pavements' values were more constant and higher on the average. This report discusses the possible explanations for the low load transfer and concludes that the 15' joint spacing is not at fault and supports the opinion that the saturated subgrade/base (as described in the report) could be the cause for the poor results.

Additional research into the effects of subgrade moisture and/or drainable bases, such as 2 foot rock fill, is recommended.
